Manhole Inspection Summary

Manhole # S37YY_033MH

Insp Date: **12/29/06 9:35 AM**

Location Address: **600 OLD YORK RD**

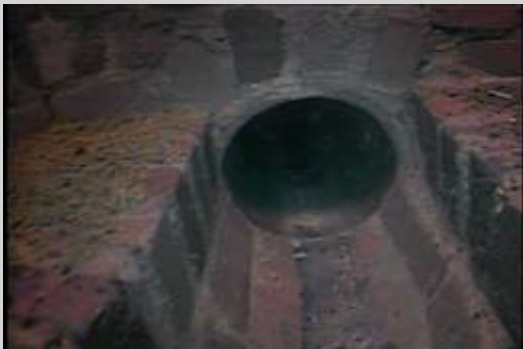
8 in. Circular Gravity Sewer Pipe In @ 3 O'Clock

Pipe Material: **Clay** ☐ Pipe Lined

Invert Depth: **6.60** (ft.) Flow Characteristics: **Slow**

Infiltration: **None** Pipe Seal Cond: **Unknown**

Connects To: **Dead End**

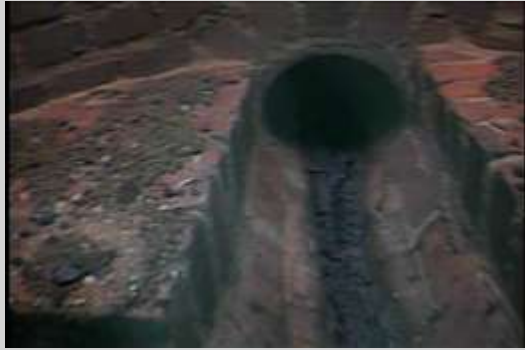
8 in. Circular Gravity Sewer

Pipe Material: **Clay** ☐ Pipe Lined

Infiltration: **None** Pipe Seal Cond: **Unknown**
